REMOVAL ACTION PLAN  
FOR  
CHICAGO MODERN PLATING CO.  
CHICAGO, ILLINOIS

Prepared by:  
WESTON-MAJOR PROGRAMS  
Technical Assistance Team  
Region V

August 1990

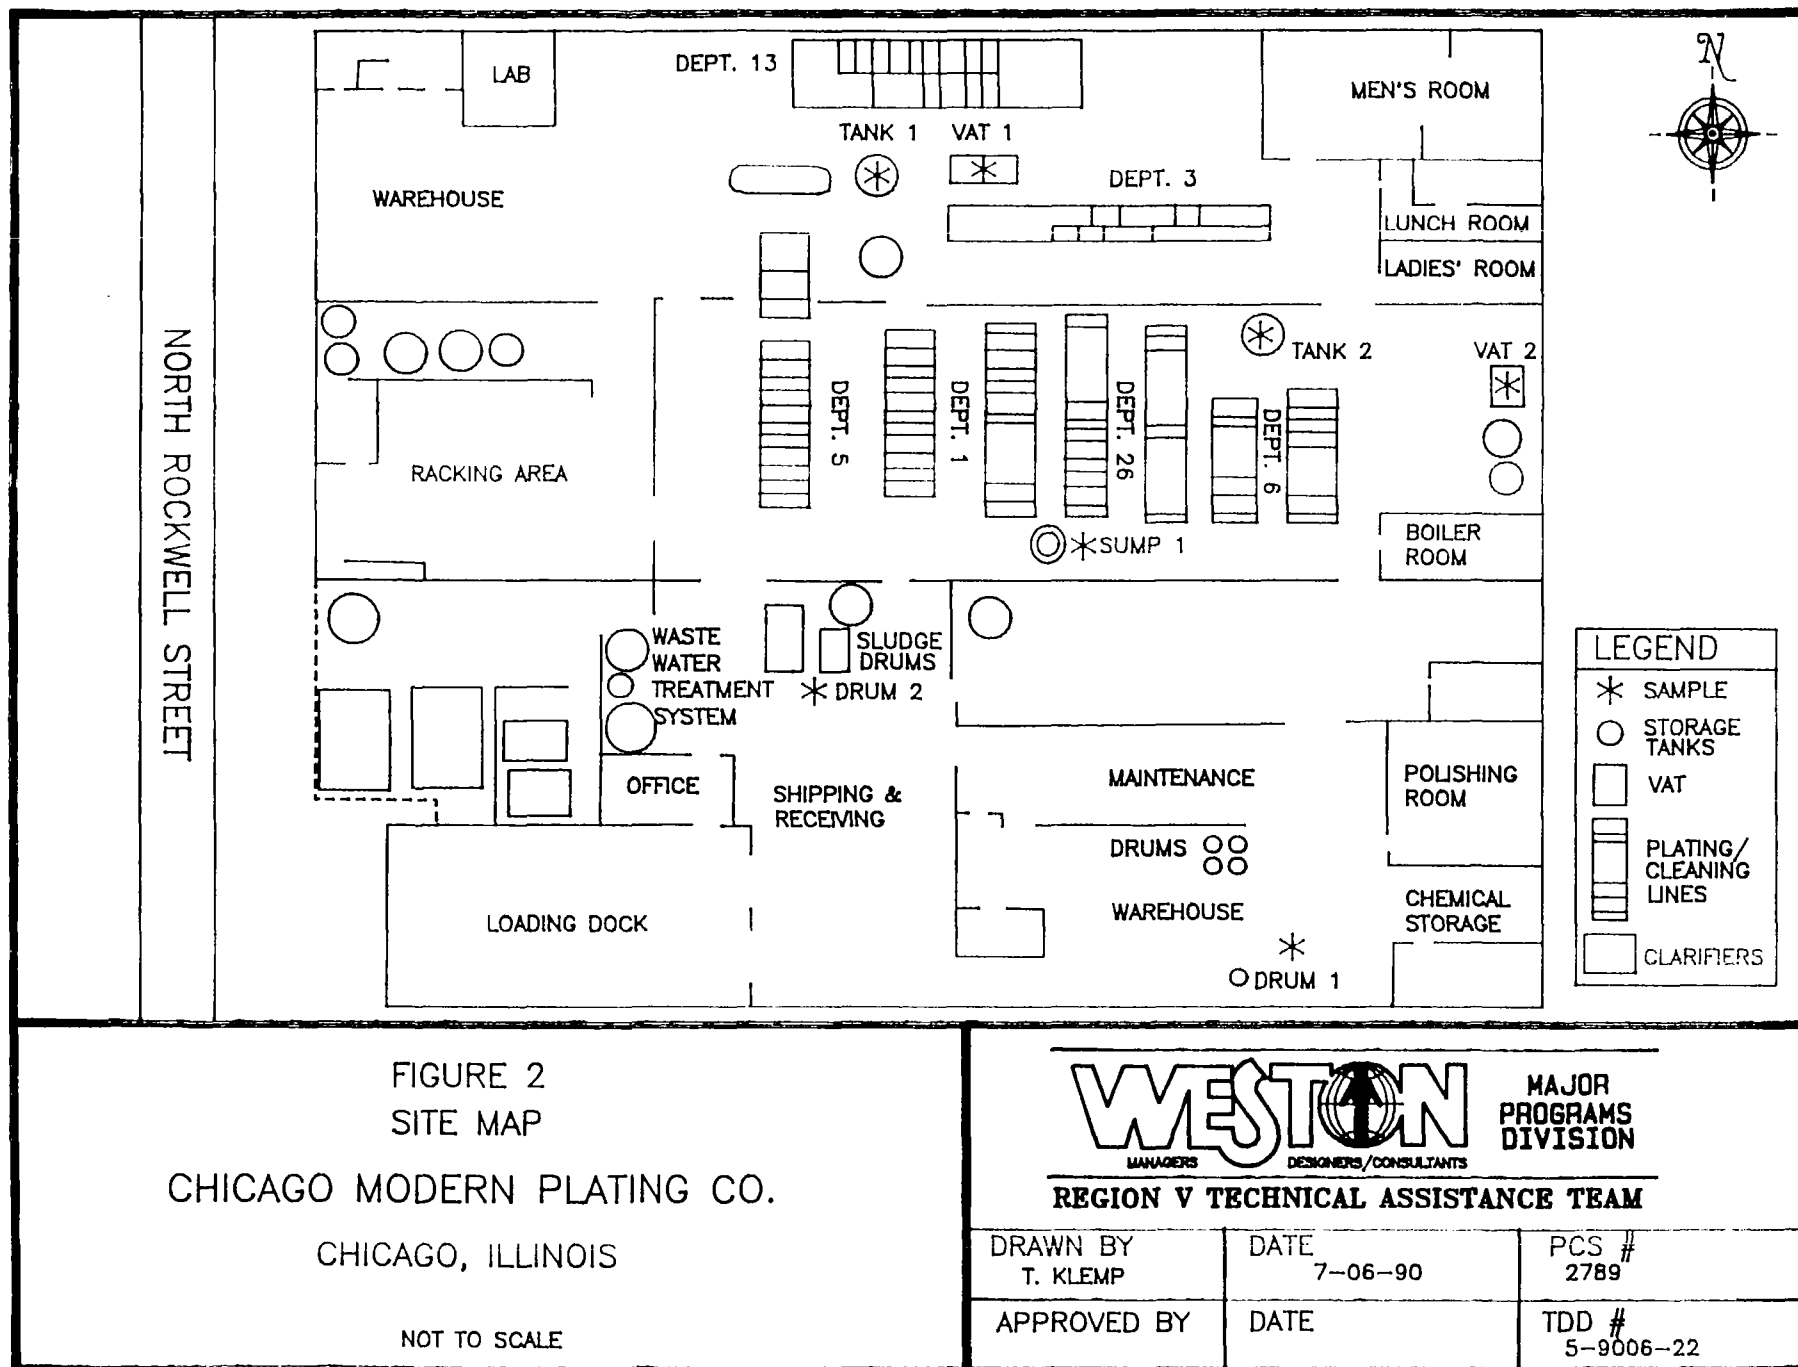
The TAT observed nine plating and cleaning lines for brass, zinc, and nickel plating in the CMP facility (Figure 2). In addition, the facility contained a polishing room, a chemical storeroom, a laboratory, a maintenance room, a racking area, two warehouse areas, a clarifier room, a shipping and receiving room, and a wastewater treatment area. Approximate volumes of materials in the cleaning and plating lines and in storage tanks are presented in Table 1.

The TAT collected seven liquid samples and one sludge sample from the CMP facility. Liquid samples were collected from two vats which contained unknown liquids, two storage tanks, a drum, and a drainage sump (Figure 2). A blank distilled water sample was also prepared. The sludge sample was collected from a drum containing sludge from the wastewater treatment system. The liquid samples from the vats, tanks, and drum were analyzed for pH, total cyanide, and Hazardous Substance List (HSL) metals. The drainage sump and blank water samples were analyzed for total cyanide and HSL metals. The sludge sample was analyzed for total and reactive cyanide, and Toxicity Characteristic Leaching Procedure (TCLP) metals. Samples were analyzed by Suburban Laboratories in Hillside, Illinois under TAT Analytical Services TDD# 5-9006-L17.

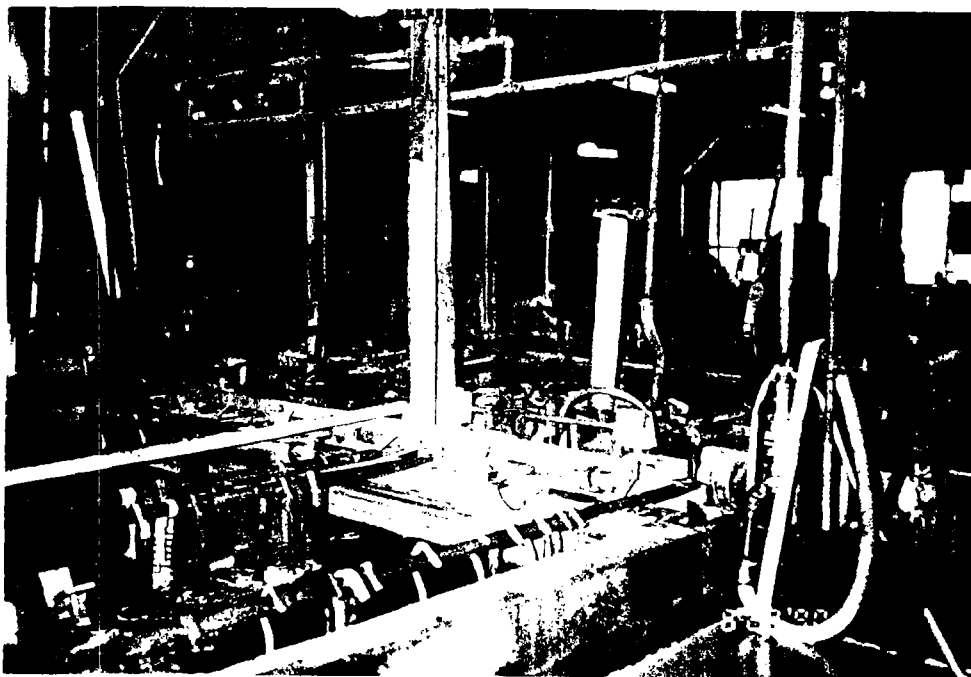
PHOTO: 1  
 SITE NAME: CHICAGO MODERN PLATING CO., CHICAGO, ILLINOIS  
 DESCRIPTION: DEPT. 6 PLATING AND CLEANING LINES, VIEW EAST.  
 DATE: 6-27-90  
 PHOTOGRAPHER: KIT NOLLER *K.N.*  
 FILM: 35MM, ISO 200

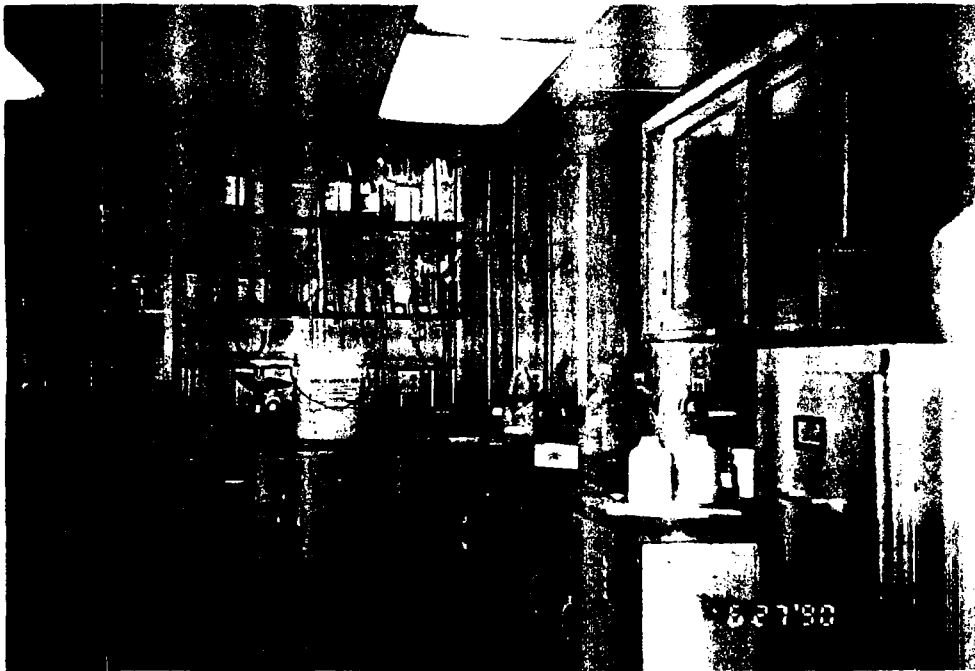
A laboratory, located in the north side of the building, contained numerous incompatible chemicals. The TAT observed a broken window on the east side of the building, under which a vat of unknown material was present. A drum of water and acid was observed near this vat. Several other boarded up windows were observed throughout the facility.

PHOTO: 5  
 SITE NAME: CHICAGO MODERN PLATING CO., CHICAGO, ILLINOIS  
 DESCRIPTION: LABORATORY, VIEW NORTH.  
 DATE: 6-27-90  
 PHOTOGRAPHER: KIT NOLLER *KN*  
 FILM: 35MM, ISO 200

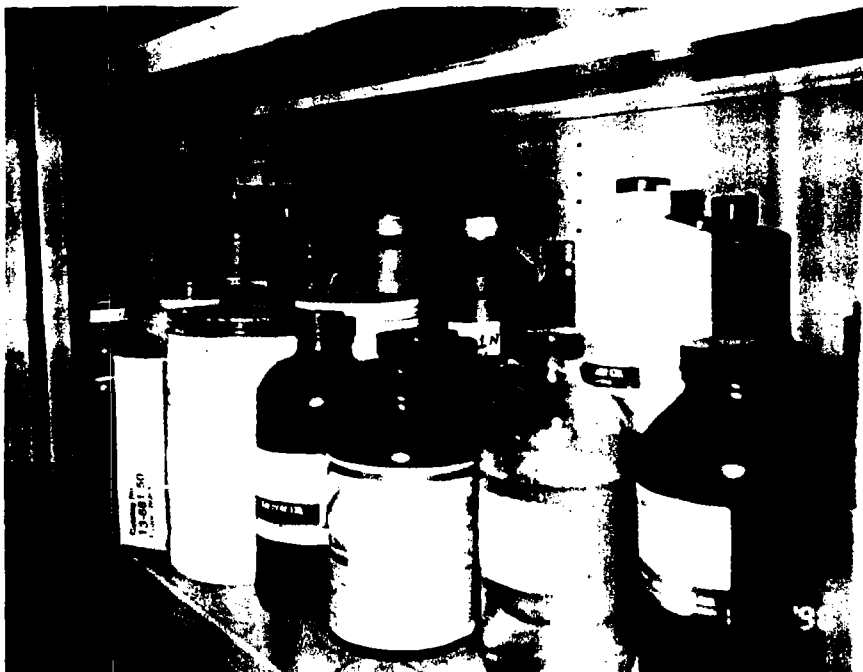
PHOTO: 6  
 SITE NAME: CHICAGO MODERN PLATING CO., CHICAGO, ILLINOIS  
 DESCRIPTION: CHEMICALS STORED ON LABORATORY SHELVES.  
 DATE: 6-27-90  
 PHOTOGRAPHER: KIT NOLLER *KN*  
 FILM: 35MM, ISO 200

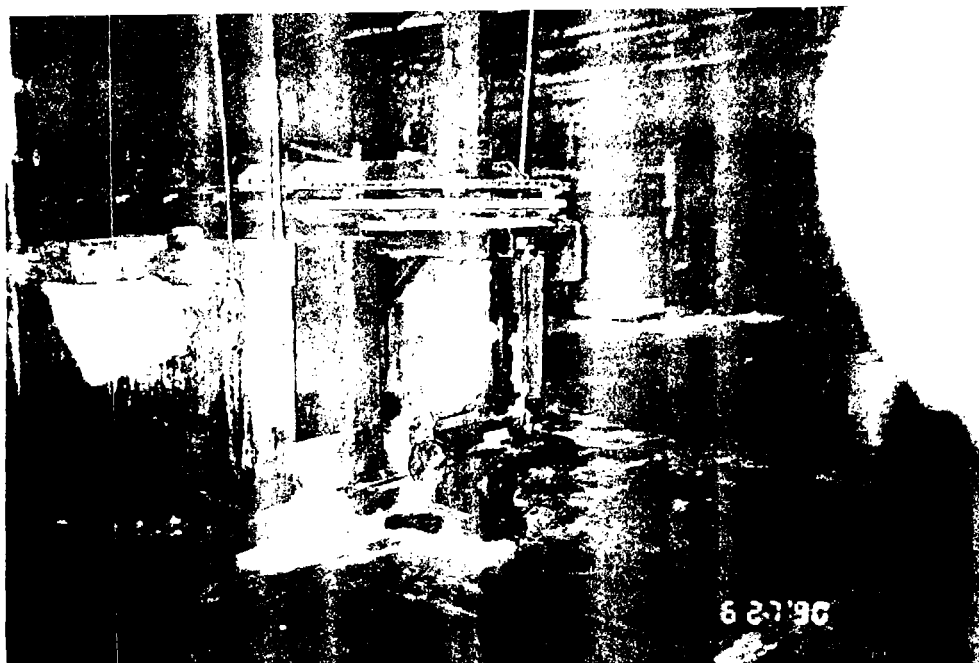
Alkaline zinc solution, caustic cleaner, HCl, sulfuric acid ( $H_2SO_4$ ), chromic acid, cyanide brass solution, cyanide zinc solution, nickel plating solution, and rinse water remain in the uncovered plating lines in this facility. These plating lines appeared to be corroded and have leaked onto the floor. The TAT also observed approximately 10 full or partially full bulk storage tanks located in the facility, many which were cut in half, open vats and drums of waste liquids, and approximately 80 55-gallon open-top steel drums of sludge from the waste water treatment system. The TAT observed that several drums had leaked onto the floor.

PHOTO: 7  
 SITE NAME: CHICAGO MODERN PLATING CO., CHICAGO, ILLINOIS  
 DESCRIPTION: CORROSION OF PLATING LINES.  
 DATE: 6-27-90  
 PHOTOGRAPHER: KIT NOLLER *icw*  
 FILM: 35MM, ISO 200

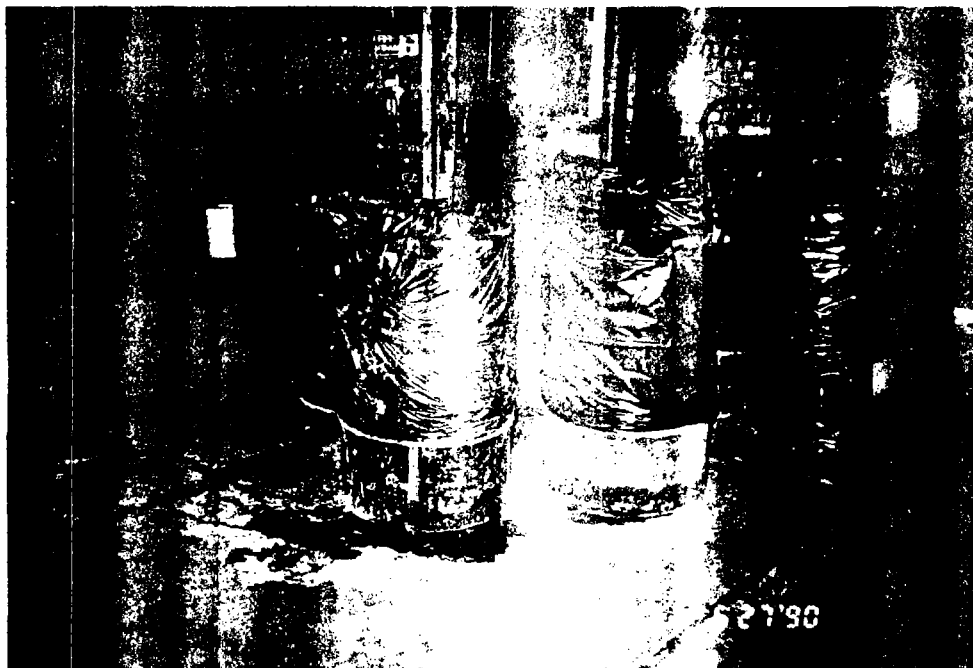
PHOTO: 9  
 SITE NAME: CHICAGO MODERN PLATING CO., CHICAGO, ILLINOIS  
 DESCRIPTION: WASTEWATER TREATMENT SLUDGE DRUMS, NOTE LEAKAGE  
 AND CONDITIONS OF DRUMS.  
 DATE: 6-27-90  
 PHOTOGRAPHER: KIT NOLLER  
 FILM: 35MM, ISO 200

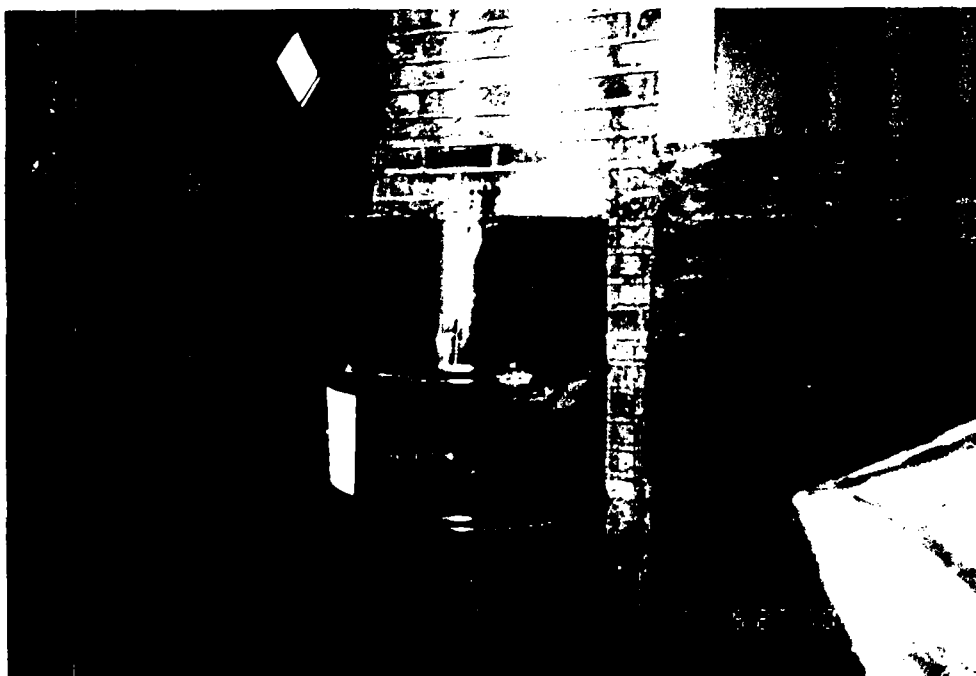
PHOTO: 10  
 SITE NAME: CHICAGO MODERN PLATING CO., CHICAGO, ILLINOIS  
 DESCRIPTION: DRUM OF UNKNOWN MATERIAL STORED NEAR ENTRANCE.  
 DATE: 6-27-90  
 PHOTOGRAPHER: KIT NOLLER  
 FILM: 35MM, ISO 200

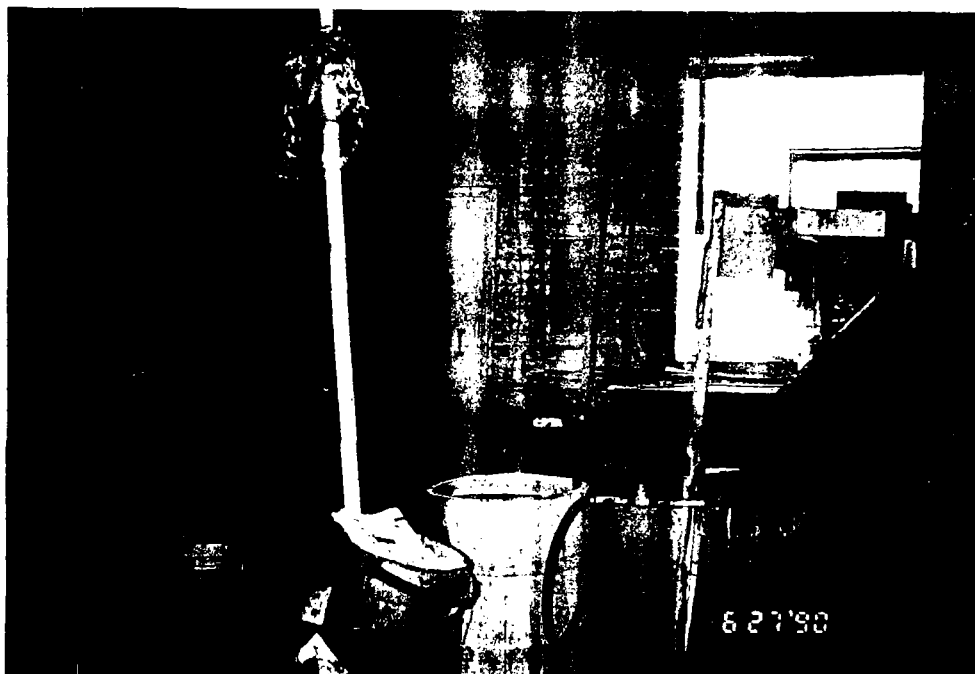
The CMP site is located in a mixed residential/commercial/industrial area on the north side of Chicago. An open broken window was observed on the east side of the building. The TAT observed a vat of unknown material with a pH of 12.8 and 1.77% total cyanide directly beneath this window. Stored directly across from this vat was a drum of acid and water with a board lain across the top. Other broken windows in the facility have been boarded shut. Numerous open drums, tanks, and vats containing hazardous material remain in the building. Drums were observed near entranceways and open vats were observed directly below broken windows. The plating lines are uncovered and contain plating solutions, acids, caustic cleaners, and rinse water. A partially full 3000-gallon tank of HCl was observed within a fenced cement yard outside of the building. The cyanide could react with the acid and lethal concentrations of HCN gas could be generated.

PHOTO: 13  
 SITE NAME: CHICAGO MODERN PLATING CO., CHICAGO, ILLINOIS  
 DESCRIPTION: BOARDED WINDOW ABOVE VAT OF UNKNOWN MATERIAL,  
 NOTE PROXIMITY TO ENTRANE AND OPEN DRUMS.  
 DATE: 6-27-90  
 PHOTOGRAPHER: KIT NOLLER  
 FILM: 35MM, ISO 200

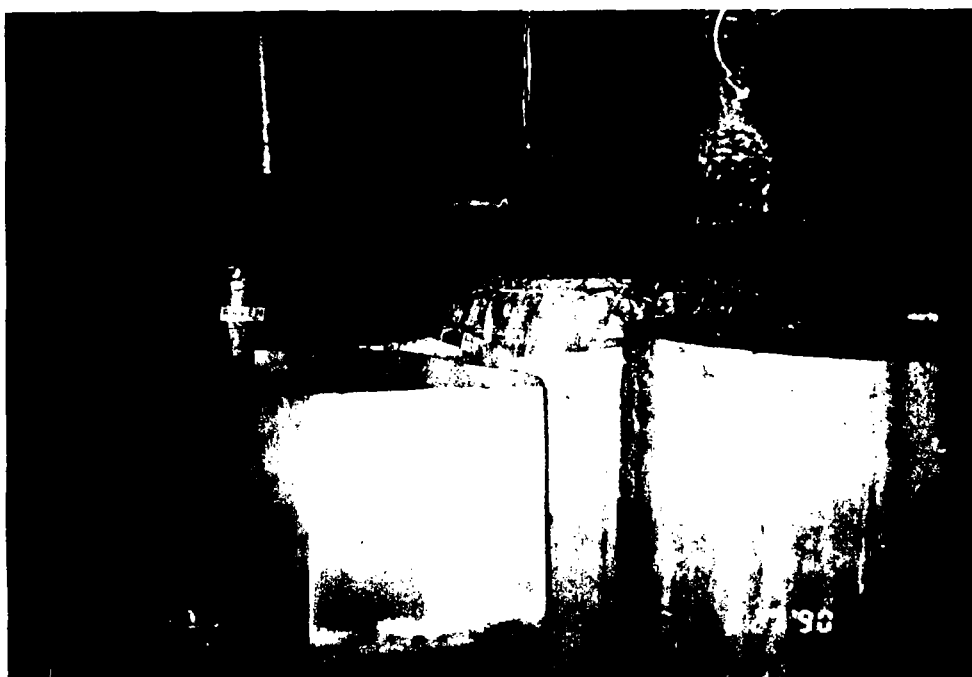
PHOTO: 14  
 SITE NAME: CHICAGO MODERN PLATING CO., CHICAGO, ILLINOIS  
 DESCRIPTION: STORAGE TANKS OF UNKNOWN WASTES.  
 DATE: 6-27-90  
 PHOTOGRAPHER: KIT NOLLER  
 FILM: 35MM, ISO 200

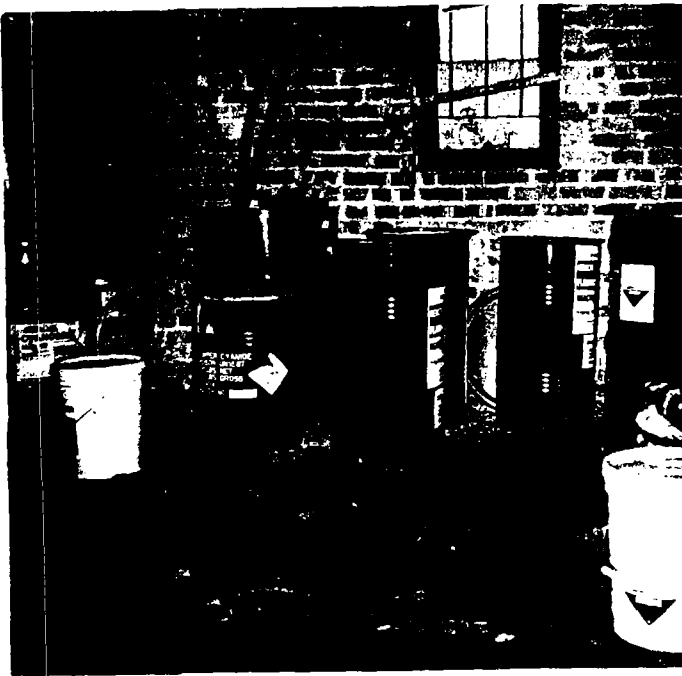
PHOTO: 15  
 SITE NAME: CHICAGO MODERN PLATING CO., CHICAGO, ILLINOIS  
 DESCRIPTION: CHEMICAL STORAGE ROOM, NOTE BOARDED WINDOW.  
 DATE: 6-27-90  
 PHOTOGRAPHER: KIT NOLLER *KN*  
 FILM: 35MM, ISO 200

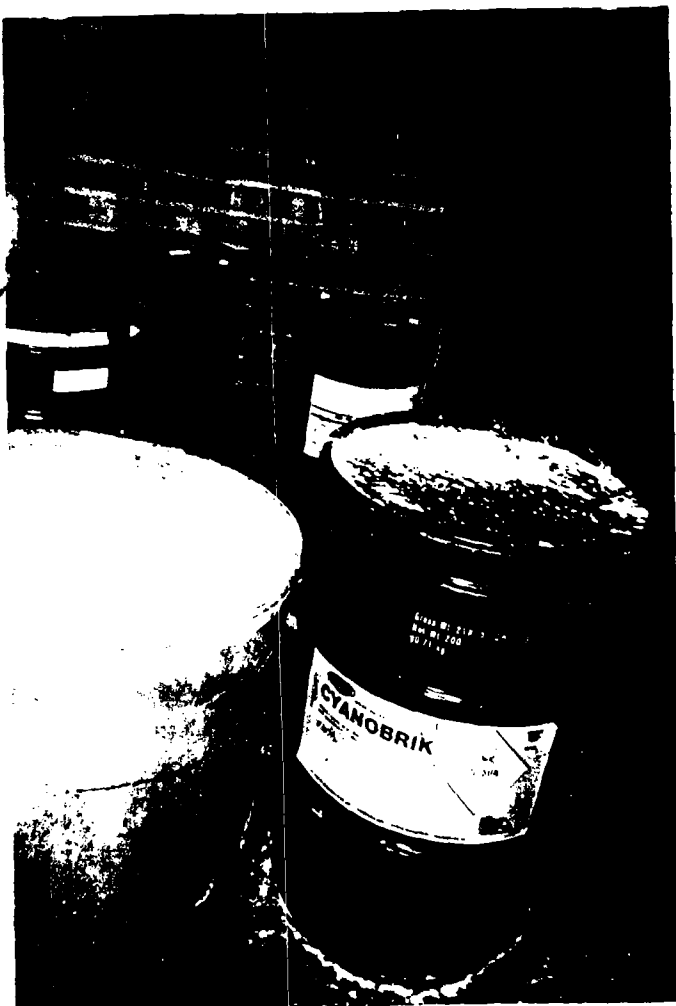
PHOTO: 16  
 SITE NAME: CHICAGO MODERN PLATING CO., CHICAGO, ILLINOIS  
 DESCRIPTION: UNKNOWN POWDER ON CHEMICAL DRUMS IN CHEMICAL STORAGE AREA. NOTE POISON LABEL.  
 DATE: 6-27-90  
 PHOTOGRAPHER: KIT NOLLER *KN*  
 FILM: 35MM, ISO 200

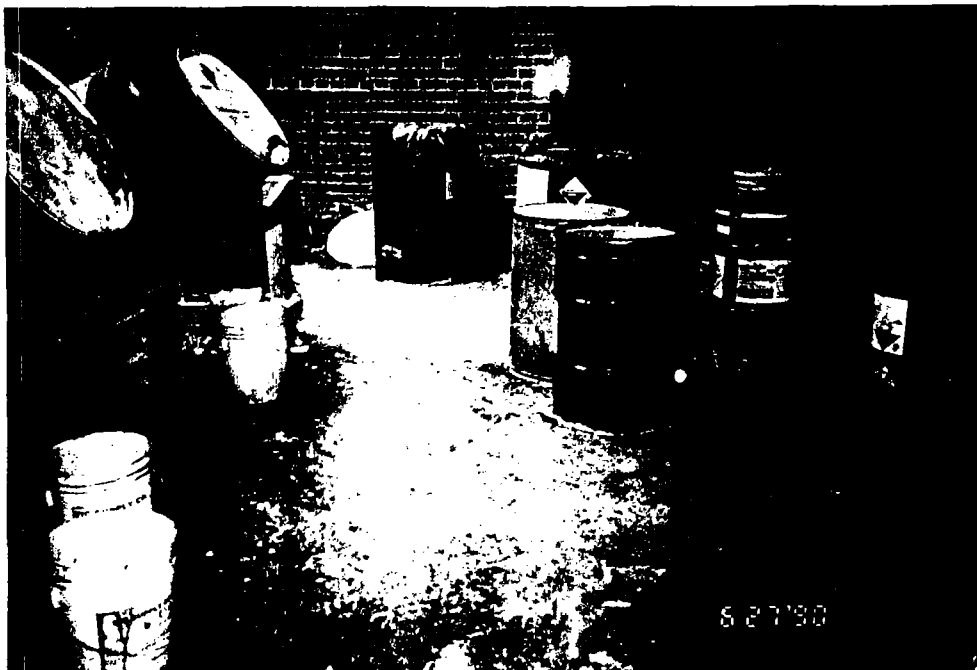
PHOTO: 17  
 SITE NAME: CHICAGO MODERN PLATING CO., CHICAGO, ILLINOIS  
 DESCRIPTION: CAUSTIC CLEANER STORAGE AREA. NOTE CORROSIVE  
 LABELS AND MATERIAL ON FLOOR.  
 DATE: 6-27-90  
 PHOTOGRAPHER: KIT NOLLER *KN*  
 FILM: 35MM, ISO 200
